A STUDY OF THE EFFECTS OF BIAXIAL STRESS AND LOW TEMPERATURE ON THE FAILURE OF MILD STEEL CYLINDERS

A Thesis Submitted to the

the Requirements for the Degree of Master of Science

Naval Architecture and Marine Engineering

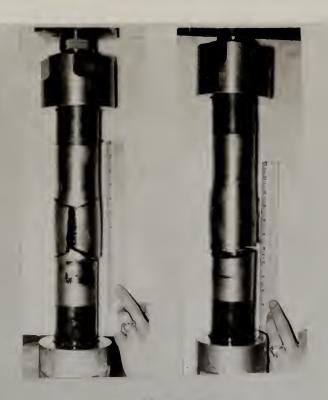
TEST A-1
Stress Ratio 1.75
Failure Temperature -31 F

Tests A-1 and A-2 again, show the characteristics of ductile failure although in some cases there may have been a minute region of brittle failure. There was approximately 25% elongation in the test sections and the characteristic silky sheen indicating necking down in the vicinity of the breaks. It is believed that some bending was introduced in A-1, probably due to a bit of foreign matter on the disc of the universal in the lower platen of the testing machine.

Specimens A-3, A-4, and A-6, all have the visual characteristics of ductile failure. A-3 failed with a considerably larger report than any of the other tests and at low values of stress, leading to the belief that this may have been brittle at the start and then propagated as ductile. Specimen A-6 is believed to have originated as brittle although here again if a brittle area exists, confirmation of this belief could be obtained only by means of microscopic examination. This specimen has a considerable amount of essentially 45 degrees Lueder's Lines, and is the only one with such lining.

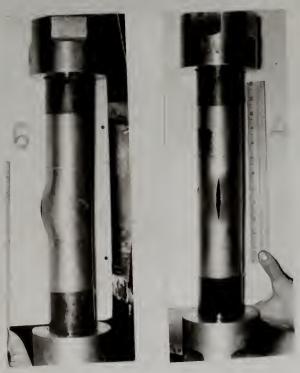
FIGURE 16

Specimen A-5, as can be seen from the photographs, failed in both longitudinal and circumferential directions. The circumferential breaks are very definitely brittle failures as indicated by the grainy structure and the lack of local necking in the vicinity. Chevrons on both circumferential breaks point to the crack origin in the longitudinal break section. Parts of the longitudinal break propagated as brittle and it is believed the origin of the fracture was in the ductile region. It is assumed

that failure started in the region of maximum bulging of the tube, or the ductile region. Here again, a microscopic examination of this area might reveal a brittle region of the origin changing to ductile and back again to brittle for the remainder of the break.
